NCHRP

SYNTHESIS 562

Repair and Maintenance of Post-Tensioned Concrete Bridges

A Synthesis of Highway Practice

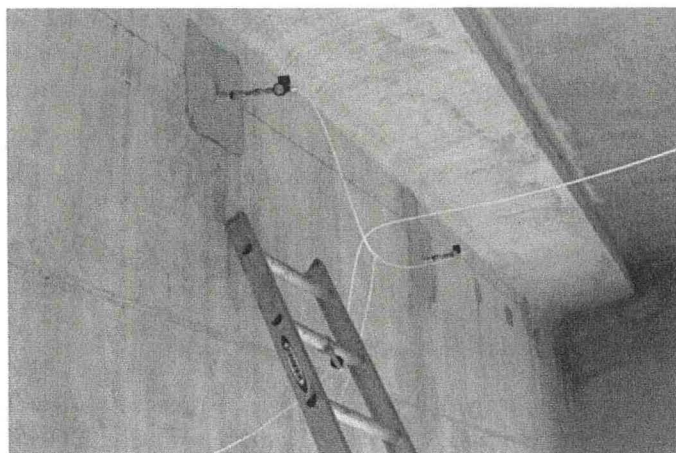
Figure 23. Grout drying.

The study also assessed a method of drying the grout to remove residual moisture in the tendons. Tendon laboratory mock-ups were constructed using layers of soft and hardened grout to simulate the tendons found in the bridge. Dehumidified air was pumped through the tendon to remove moisture from the grout until the relative humidity of grout at the air outlet reached equilibrium with the input air (see Figure 23). Although the methodology proposed effectively dried the grout, the use of atmospheric air caused corrosion of the prestressing steel. Thus, it was recommended to use the grout-drying technique in conjunction with a corrosion inhibitor. As a result of the research project report, FDOT modified the proposed repair strategy to include grout drying instead of grout removal.

vacuum-assisted grouting. Stage two consisted of the grout-drying process. Grout drying began in July 2018 and continued through January 2019. The criteria for acceptance for drying of the soft grout was set as either the relative humidity from the outlet ports had reached 20% or the moisture content of a sample of soft grout taken from the tendon was 40% or less. The dried air flowed from the center of the span outwards to minimize leakage and maintain air flow throughout the length of the tendon. Air flow rate, air temperature, and relative humidity at the inlet and outlet were monitored throughout the drying process (see Figure 23). During grout drying, while the contractor was obtaining a grout sample to determine the moisture content, a failed strand due to corrosion was discovered in one of the tendons. The discovery of the failed strand validated the decision to include supplementary post-tensioning tendons in Phase 2 repairs. Following grout drying, PT tendons were impregnated with a proprietary corrosion inhibitor—a hydrocarbon and silicon polymer product.

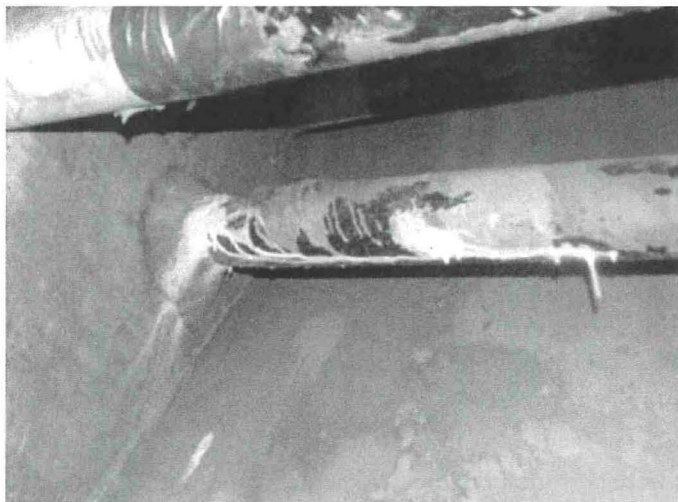
Figure 26. Nonstandard covering of tendon.

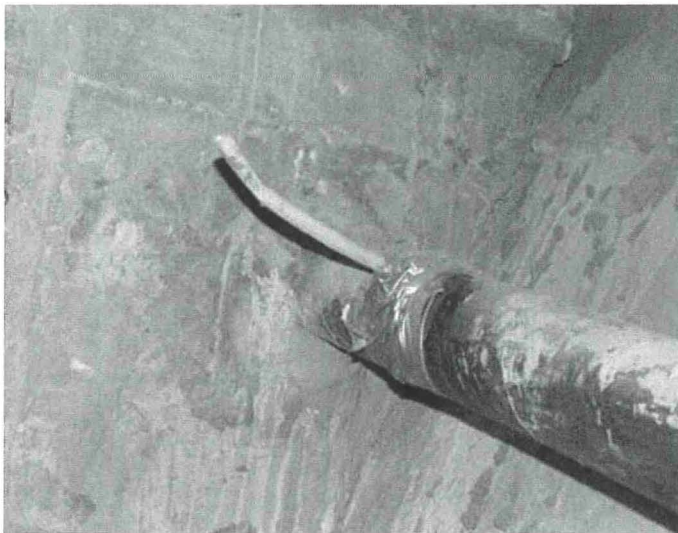
Figure 27. Improper vent connections.

Extensive nighttime inspections revealed hundreds of improperly constructed vent locations. Inspections to identify vents in need of address were difficult. In some cases, it was not easy to distinguish between polished aggregate and a vent location in need of remediation. And in some cases, vents permitted clear transmission from the deck level to tendon ducts(s). In visual inspections made with a borescope, sunlight and traffic were identifiable through vents that had not been fully grouted and sealed. In other cases, vents were found to contain poor-quality grout; it was suspected that improper grouting practices (i.e., not waiting until uniform consistency grout was outflowing before closing the vent), were used (M. K. Turner, interview, 2020).

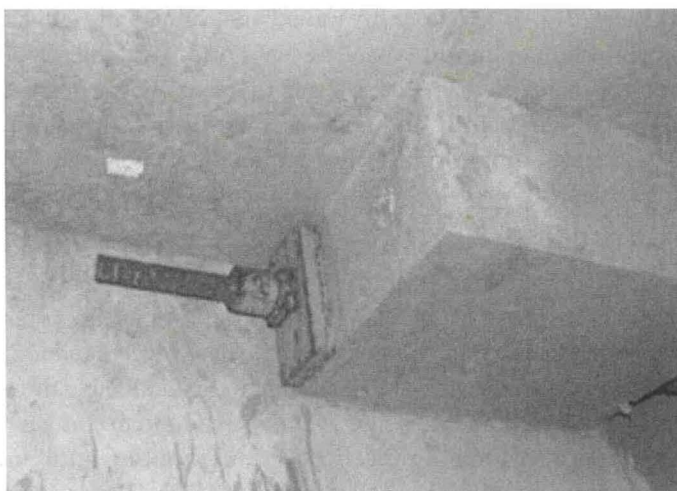
Figure 28. PT bars with corrosion.

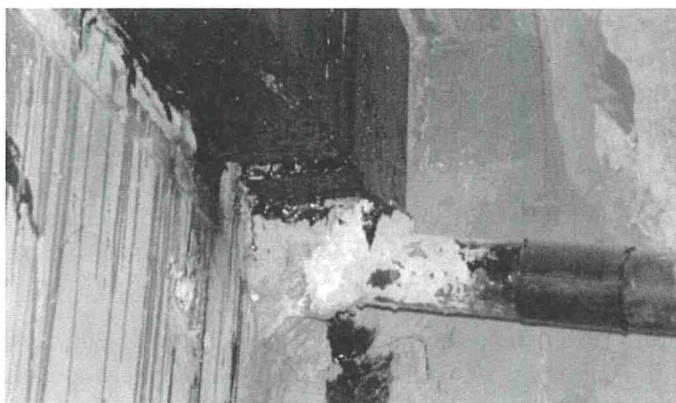
Figure 33. *Repair connection and coupler at diaphragm.*

Inspectors noted that the external tendons were in fairly good condition, though there was evidence of PT duct connection repair occurring both during and after construction (see Figure 33 and Figure 34). The connection repairs also exhibited evidence of grout leaking during its injection, which may have necessitated the repairs in the first place. Unlike current standard practice, the inspectors noted that most of the duct couplers were not waterproof. Inspectors surmised that grout leaking during construction may be associated with void presence in the hardened grout. It is important to note that connections between lengths of HDPE duct have been greatly improved and standardized since this time.

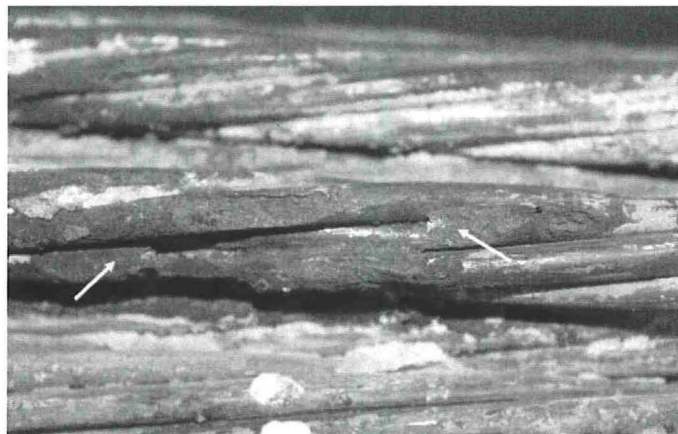
Figure 36. One broken wire and heavy section loss.

At all but two external tendon locations, the strands were observed to have Class 2 corrosion (by visual classification), or light surface rust. In one location, a tendon was observed to have one broken wire (see Figure 36); another location contained four broken wires (Figure 37). Section loss was also exhibited by adjacent wires in both locations. These two locations were the same locations where broken wires had been identified in a 2007 National Transportation Research Center visual survey; since 2007, the number of broken wires and the percentage of section loss had progressed (Parsons Brinckerhoff 2013).

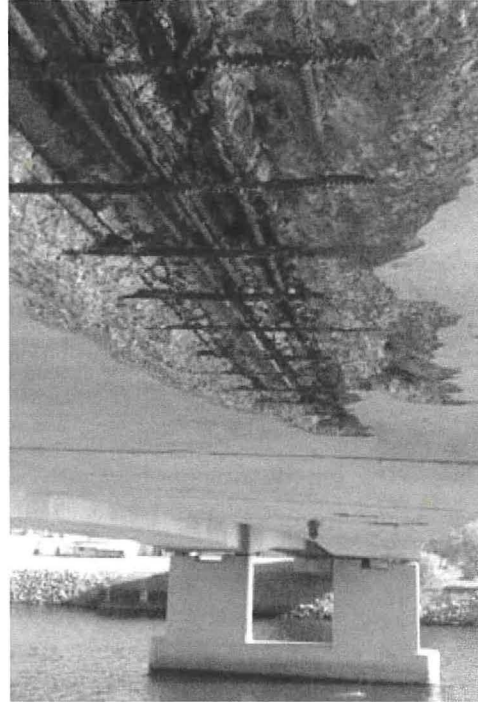
Figure 38. Corroded bottom slab tendons identified in initial inspection.

Biennial inspections were performed regularly on the Plymouth Avenue Bridge from its opening in 1983 to 2008. During this period, inspectors did not note anything to trigger an in-depth inspection. In 2010, an inspector walking through the interior of the segmental box noticed light penetrating the interior of the box, emanating from the bottom slab of the box. With manual effort and a heavy rod, the inspector was able to remove large chunks of concrete, revealing heavily corroded tendons (Figure 38).

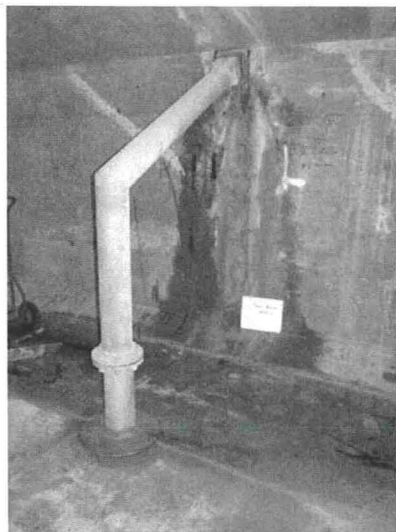
Figure 39. Evident water intrusion around drainage system.

Subsequent inspections conducted in 2010 revealed five heavily corroded tendons in one span of the eastbound structure. The identified tendons were located in the bottom slab concrete of the box adjacent to drains (Figure 39). At least two of the identified tendons were found to have lost all prestressing force. Further examination revealed that water had been penetrating the interior of the box for many years.

Damage was attributed to a long period of wet/dry cycling, during which run-off and wind-blown water from the drainage system saturated the lower slab of the box girders. The presence of moisture, combined with seasonal freeze/thaw, caused local cracking and spalling of the concrete, eventually allowing exposure of the post-tensioning tendons in the box girders' bottom slab. Significant damage was identified by the inspections, mainly in Span 3; tendons in this span were found to have lost all post-tensioning force.

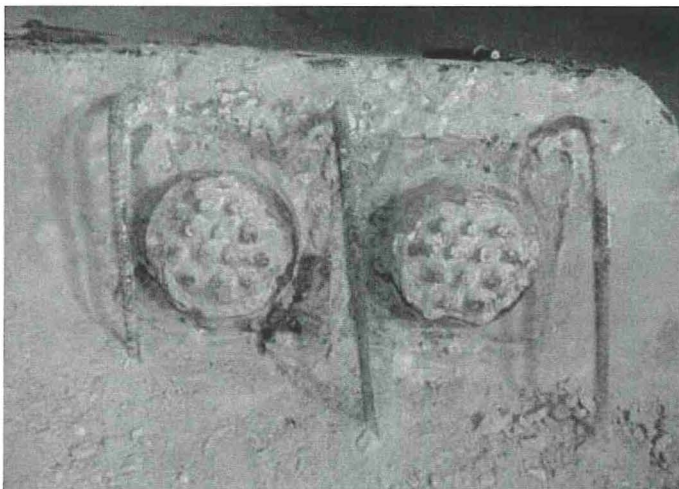
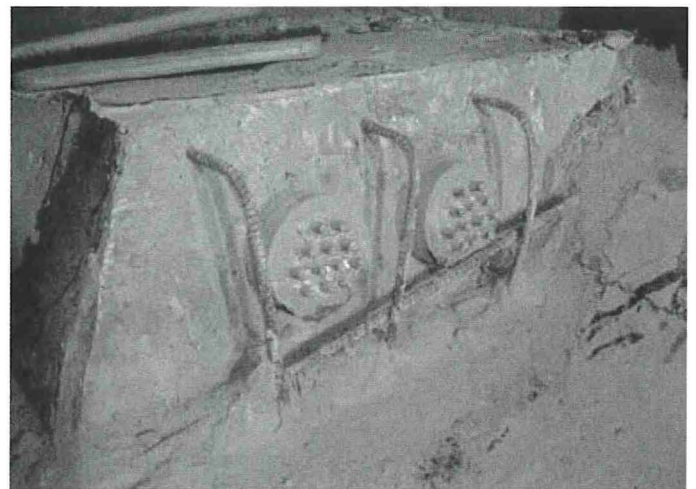
Figure 40. Exposed bottom slab continuity tendon anchorages.

Invasive inspection of selected anchorages was performed on bottom slab continuity tendons; the two pour backs selected for this investigation were chosen on the basis of observed signs of potential distress (see Figure 40). One pour back had exposed rusting reinforcement (Span 3 westbound), one pour back had observable water staining (Span 3 eastbound). Pour backs were removed with pneumatic air hammers. Grout vents in the anchorages were drilled as far as geometrically possible; grout appeared to fill the anchor. Despite the presence of water, the Span 3 eastbound anchorage was in good condition, with what was assumed to be a thin epoxy coating more than 85% of the anchorage; a light surface rust was observed on the remainder of the anchorage. The Span 3 westbound anchorage was covered in a heavier rust on the wedge and anchorage plate, but no deep pitting or section loss was noted (Corven Engineering 2010).
